# Water Supply and Environmental Crisis

Baynes Lake, Elko and Kikomun Creek Provincial Park

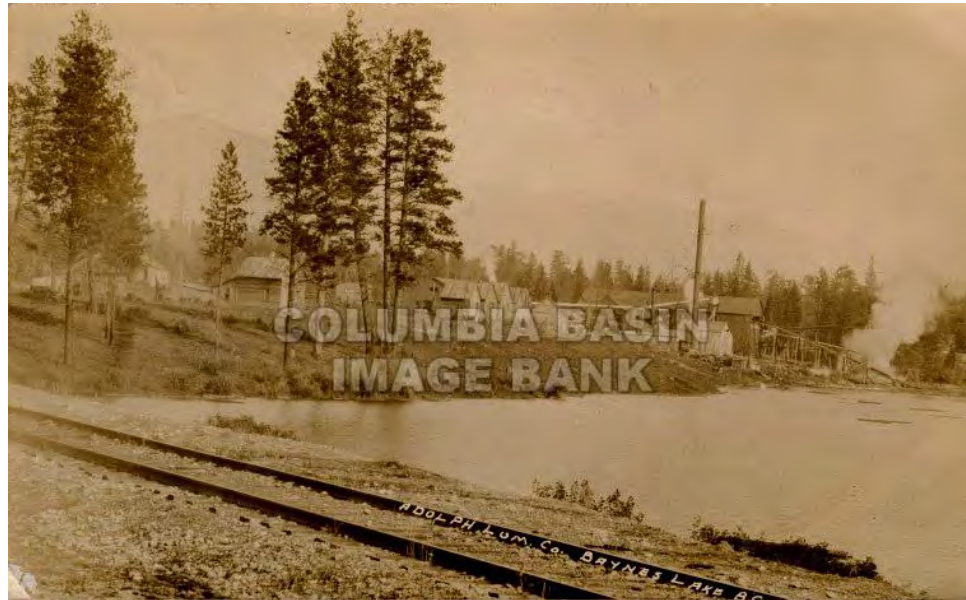
Adolph Lumber Mill - Circa 1909

- These are the Pre-Dam water levels at Baynes Lake
- They clearly show that Baynes Lake was naturally a full, Kettle Lake, year after year

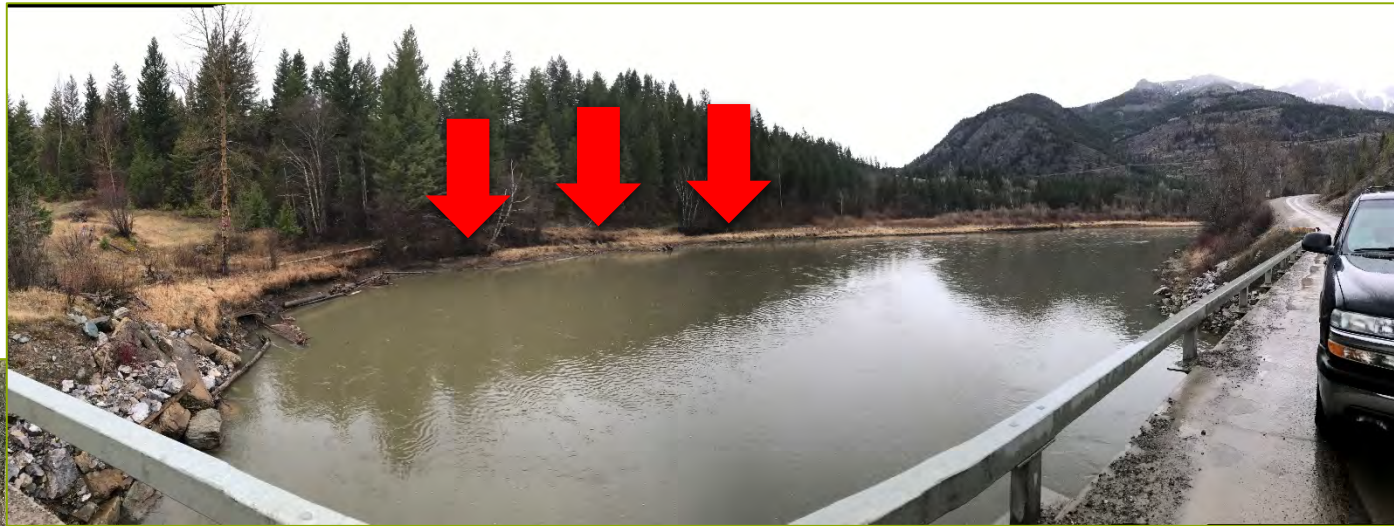
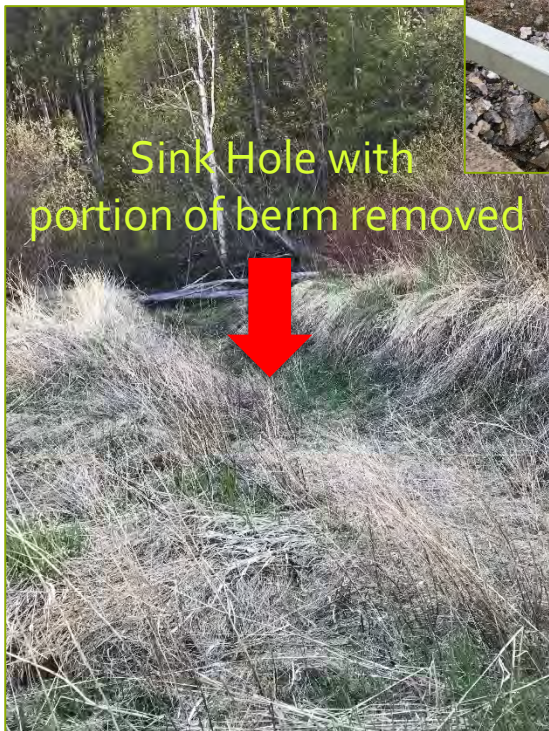
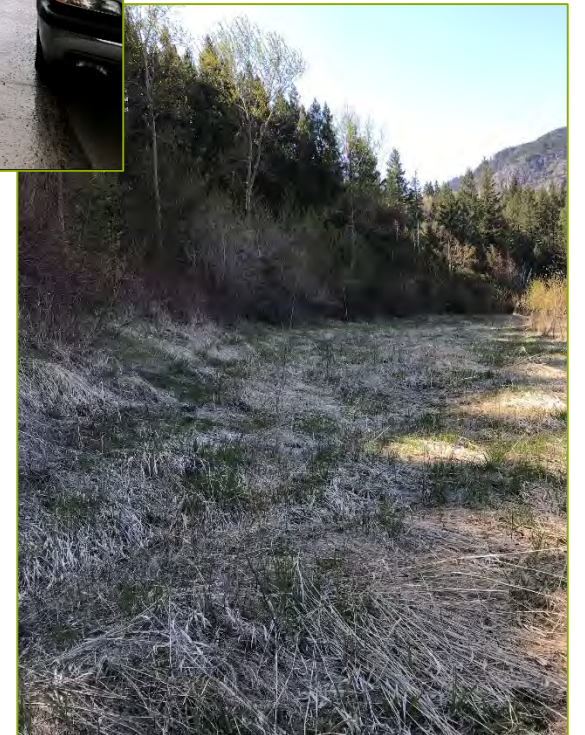
# Sink Holes and Head Pond

This is the Head Pond and Sinkholes on the western bank of the Elk River, at Elko, currently deprived of water. They connect to the Aquifer and when 'wetted', or filled with water, they provide the source water to our area (20,000 GPM)."

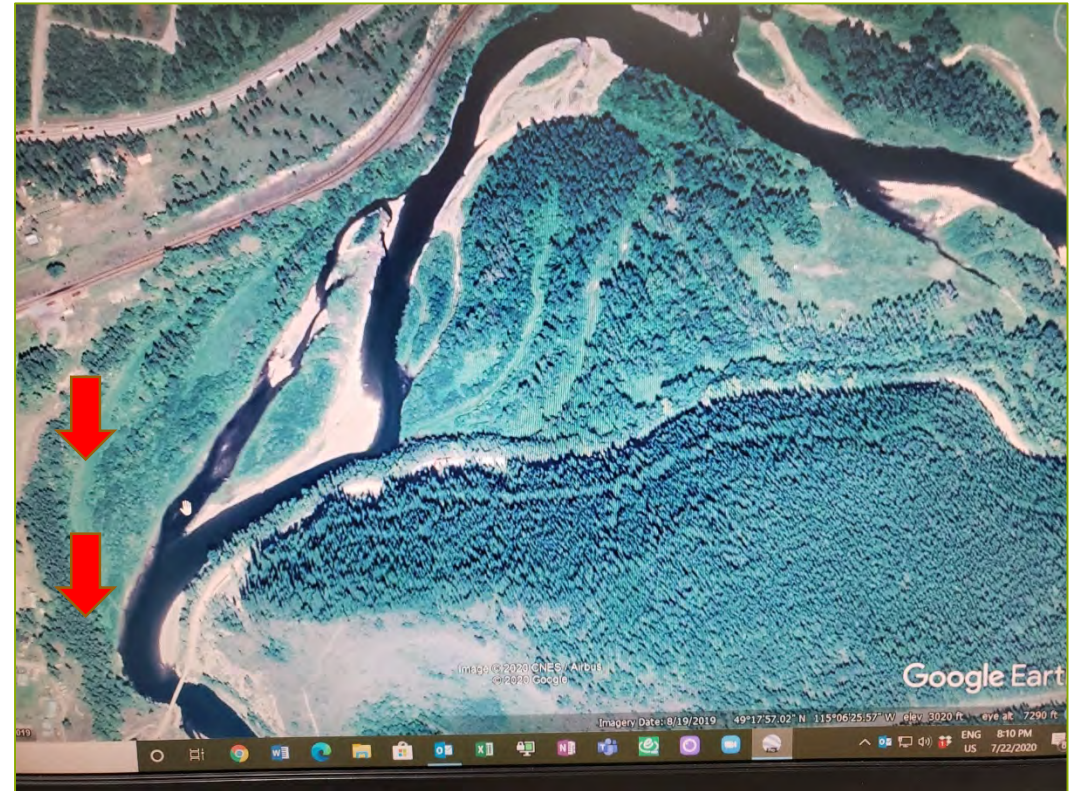
This overhead photo of the Elk River shows the historic path of the river, with the Sinkholes on the left

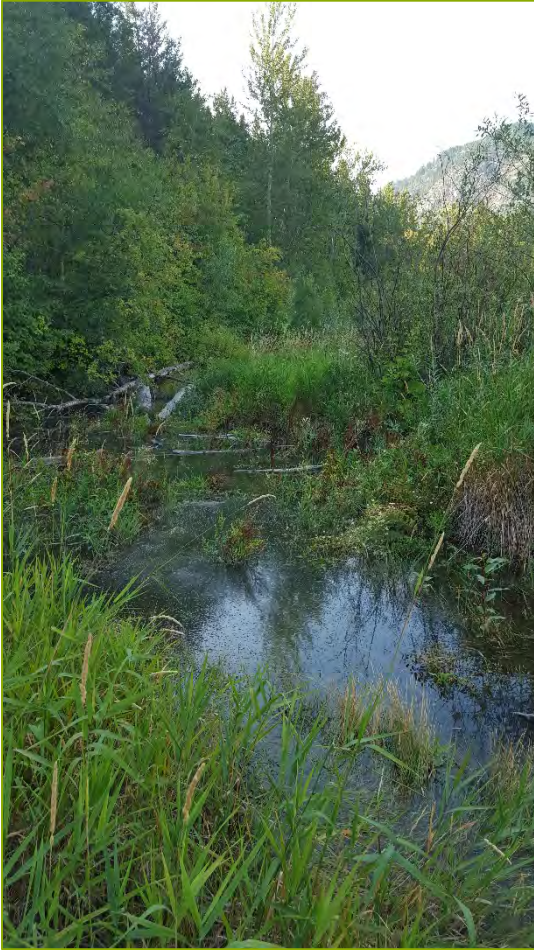
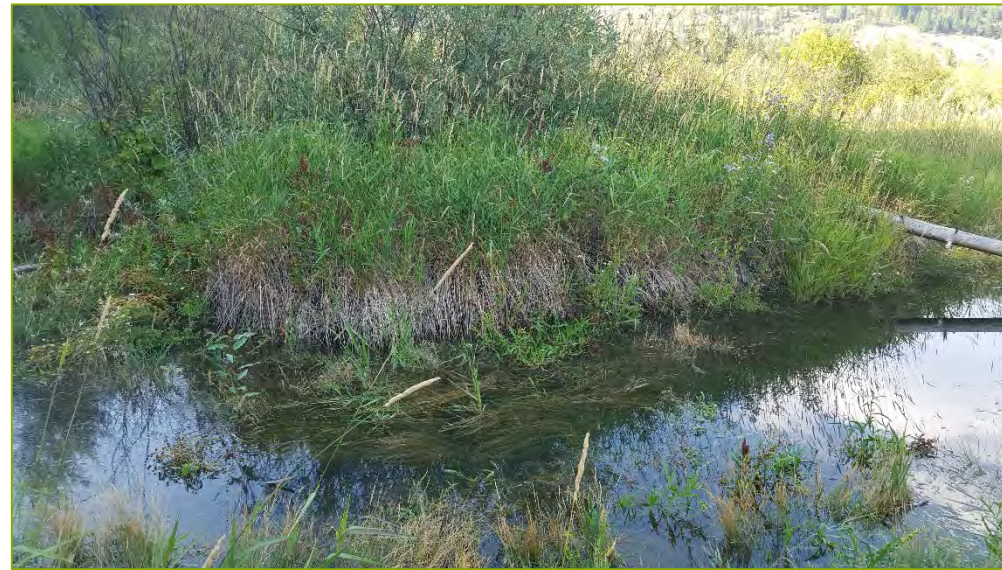
# Wetted Sink Holes

In 2009, the Comptroller of Water ordered BC Hydro to maintain the 917 level that is required to keep full pool in the Head Pond and deliver water to the Sinkholes. This produced consistent, healthy water levels for 7 years.

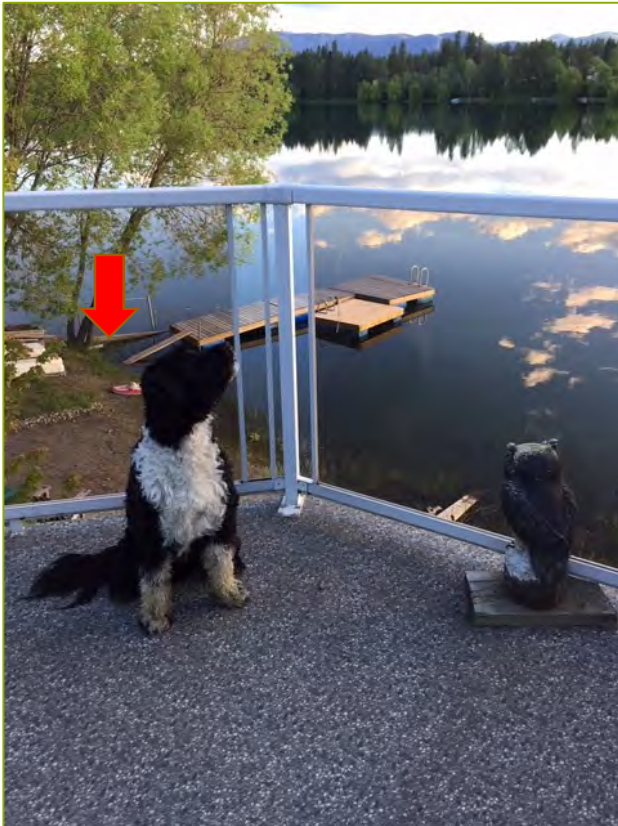
Baynes Lake - 2017

The 2016 decommissioning of the Elko Dam has now starved the sink holes of source water to the Aquifer, resulting in 3 years of declining water levels and a 7 ft. vertical drop in the surrounding lakes and ponds. It has also resulted in compromised water wells and severe habitat destruction.

(Note the island structure that has now been exposed in the middle of Baynes Lake)

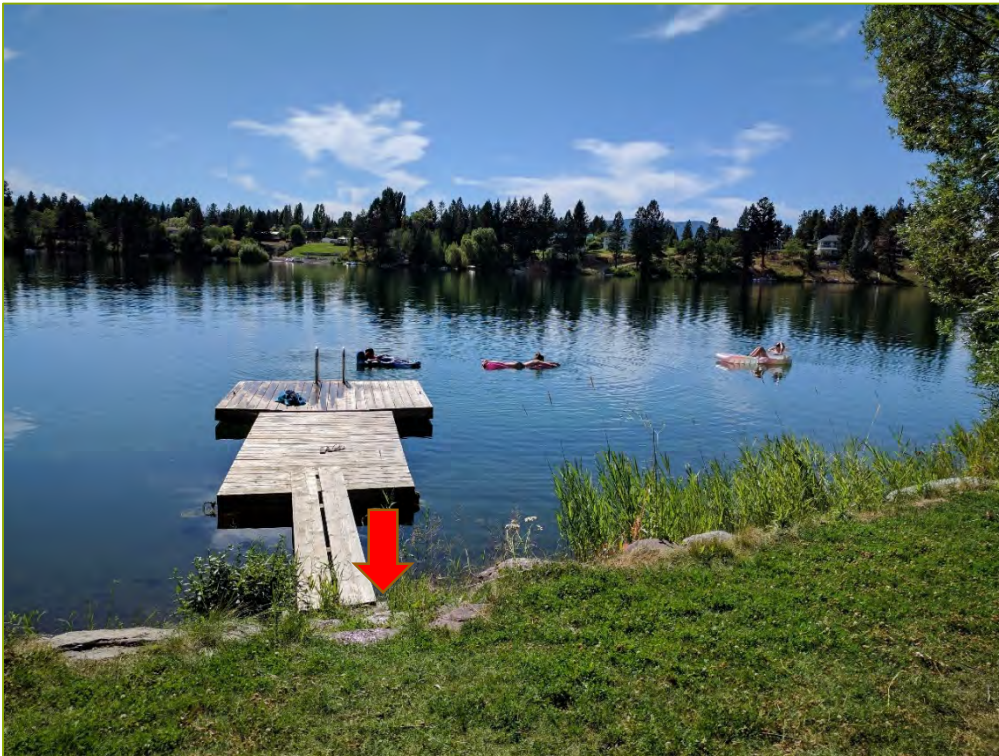
Baynes Lake - 2017

We are at record low water levels at a time when all other SE BC lakes, and rivers, are at record highs.

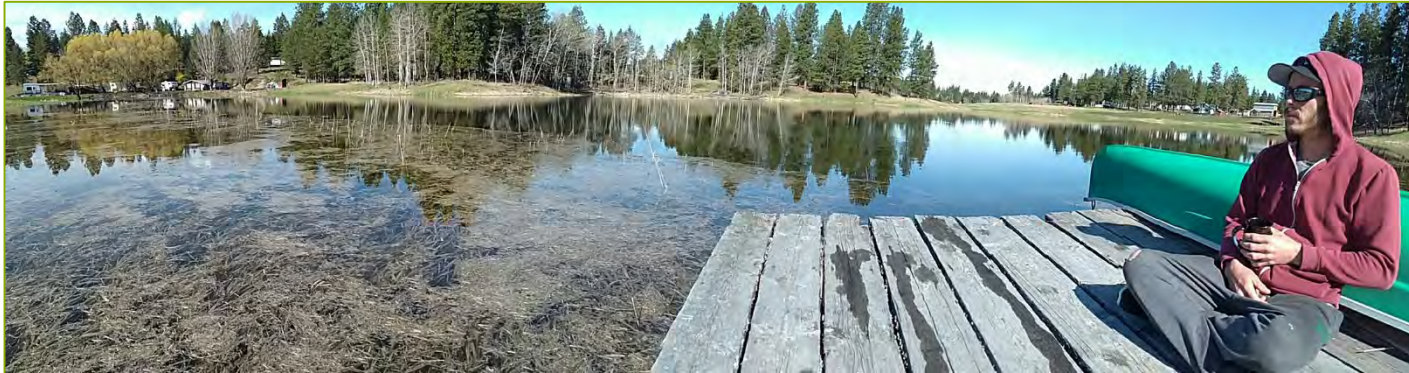
Doehle Kettle Pond - 2017

Clearly, we need our source water restored immediately!

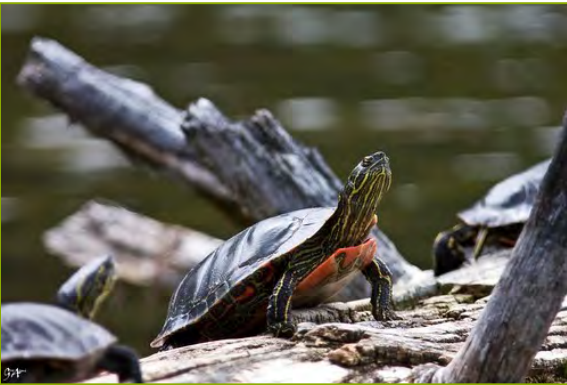
## Surveyors Lake – Kikomun Provincial Park

This crisis has also produced an environmental disaster and habitat destruction for the endangered Western Painted Turtle, and a diverse Fish and Waterfowl population. It has had the identical impact on the water levels in Kikomun Creek Provincial Park, including Surveyors Lake and connecting water channels seen here.

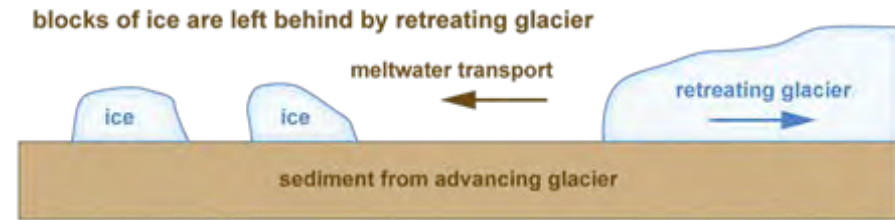
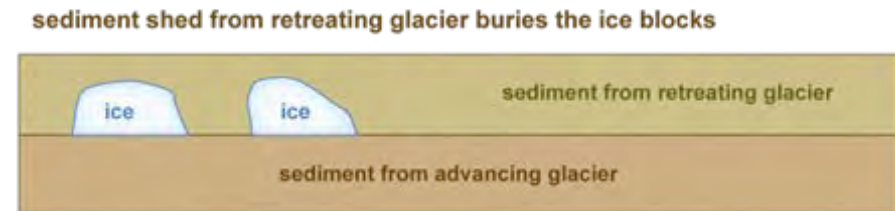
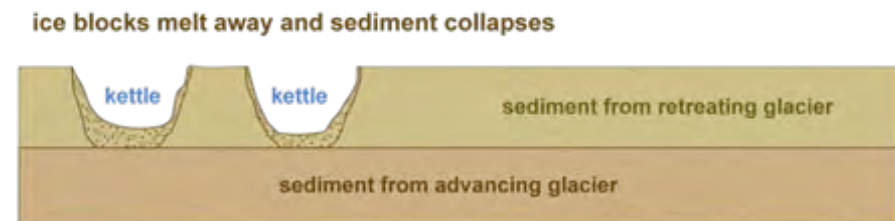
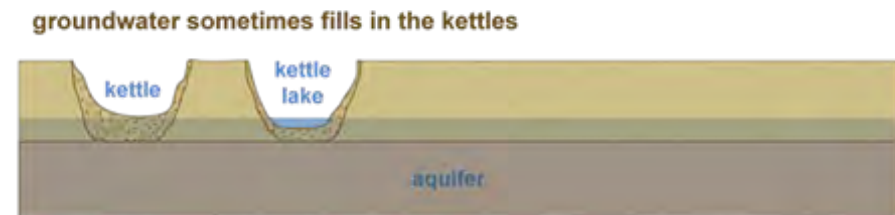
## KETTLE FORMATION

- No surface exit at Baynes lake
- Surveyor lake system has a surface exit into the Koocanusa

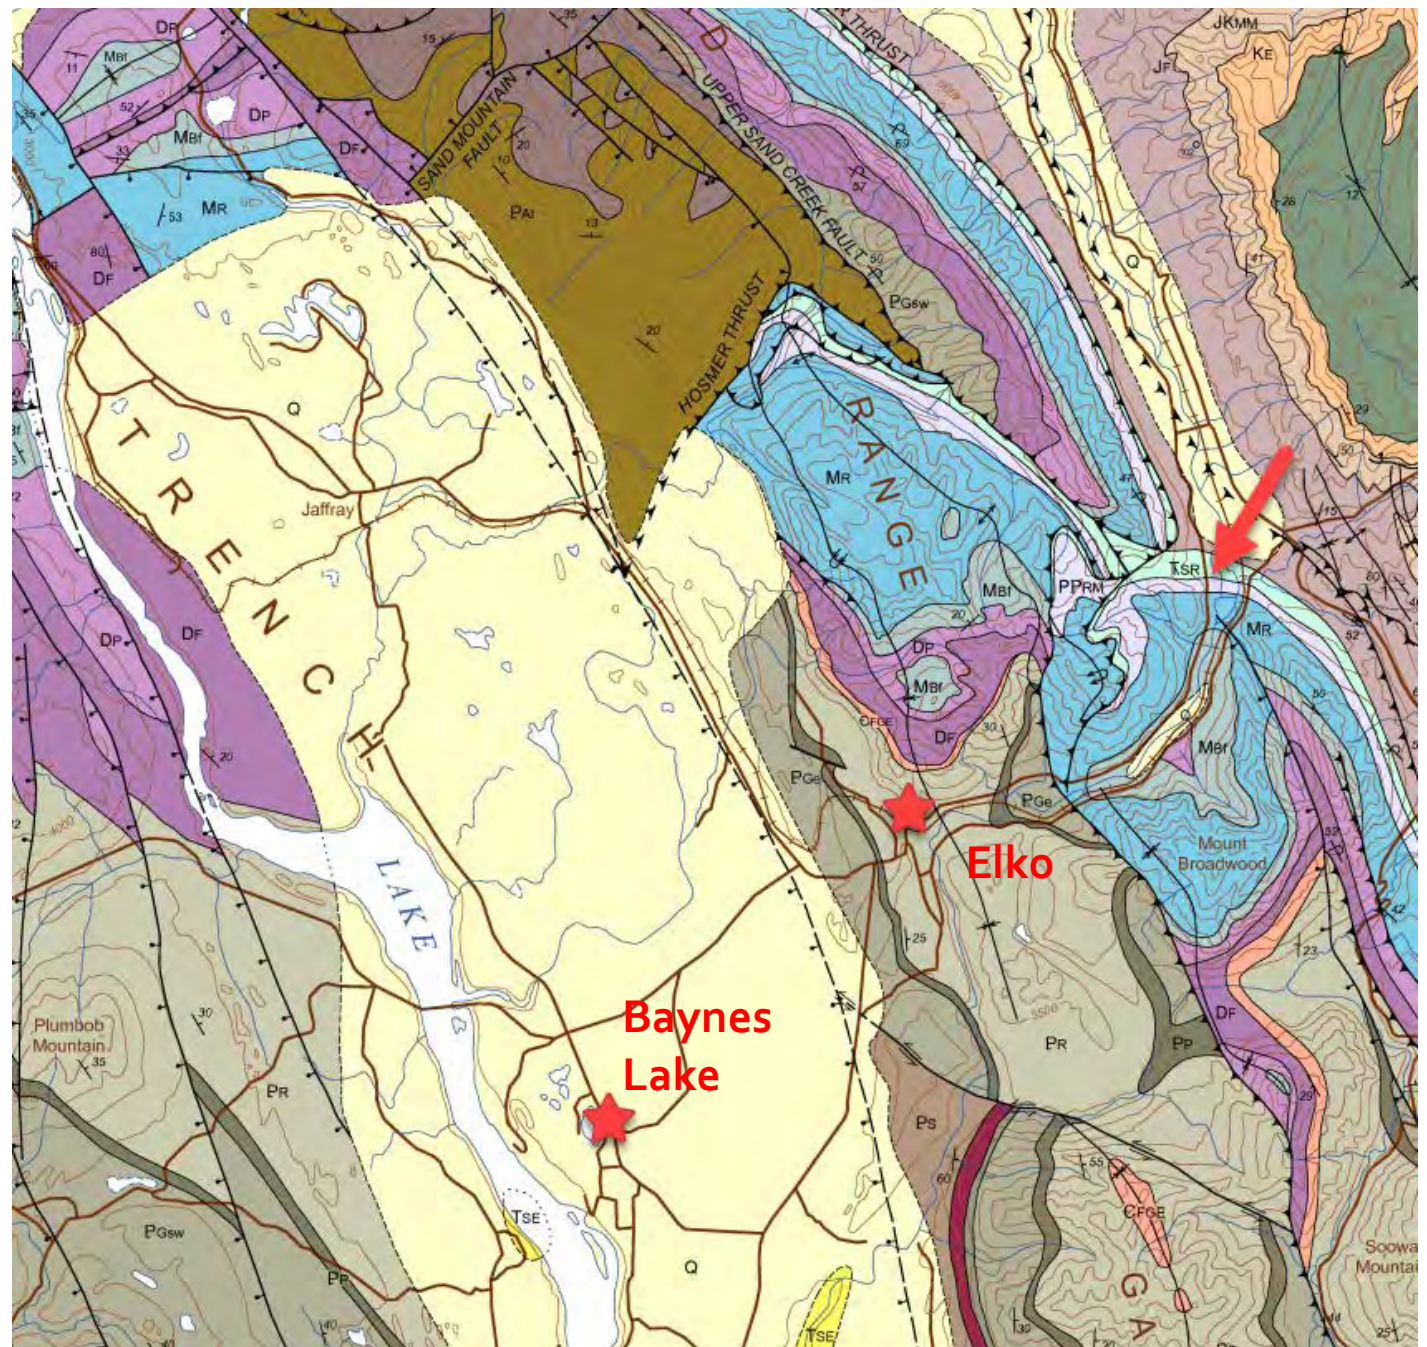
# Regional Geological Setting

- Normal fault and thrust fault patterns create structural grain in the Rocky Mountain Trench and adjacent Rocky Mountains (NW-SE trends)
- Red arrow denotes break in structural grain (NE-SW), result of transpressional wrench faulting.

- New geological mapping incorporating outcrop studies, lineament analysis, and water borehole examination, indicate a previously unmapped fault system related to wrenching between the Lizard Ranges and the Galton Ranges of the Western Rocky Mountains
